Lawrence Livermore National Laboratory

UCRL-AR-126020-10

LLNL Ground Water Project 2010 Annual Report

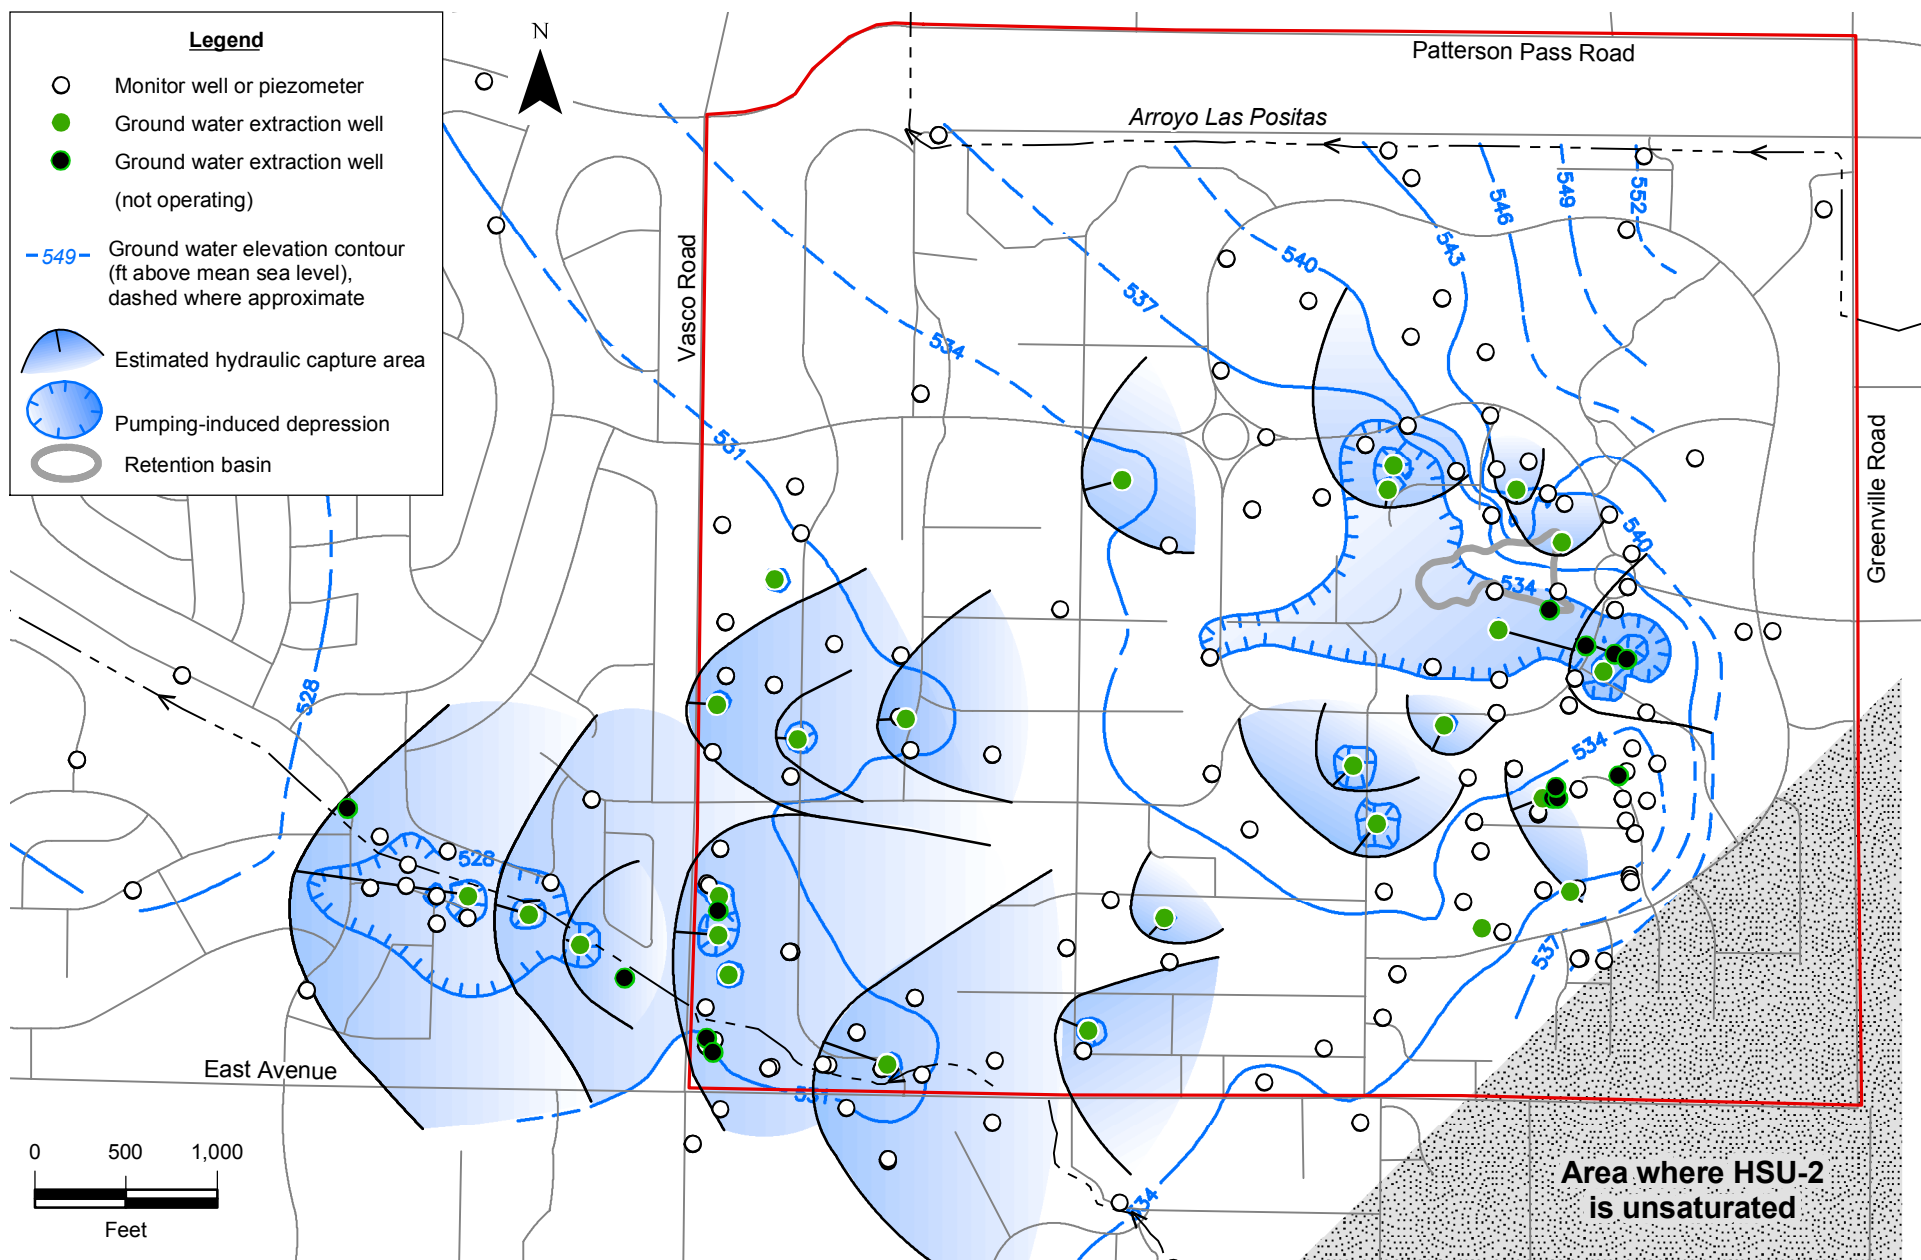
Figure 6. Ground water elevation contour map based on 197 wells completed within HSU 2 showing estimated hydraulic capture areas, LLNL and vicinity, July 2010.

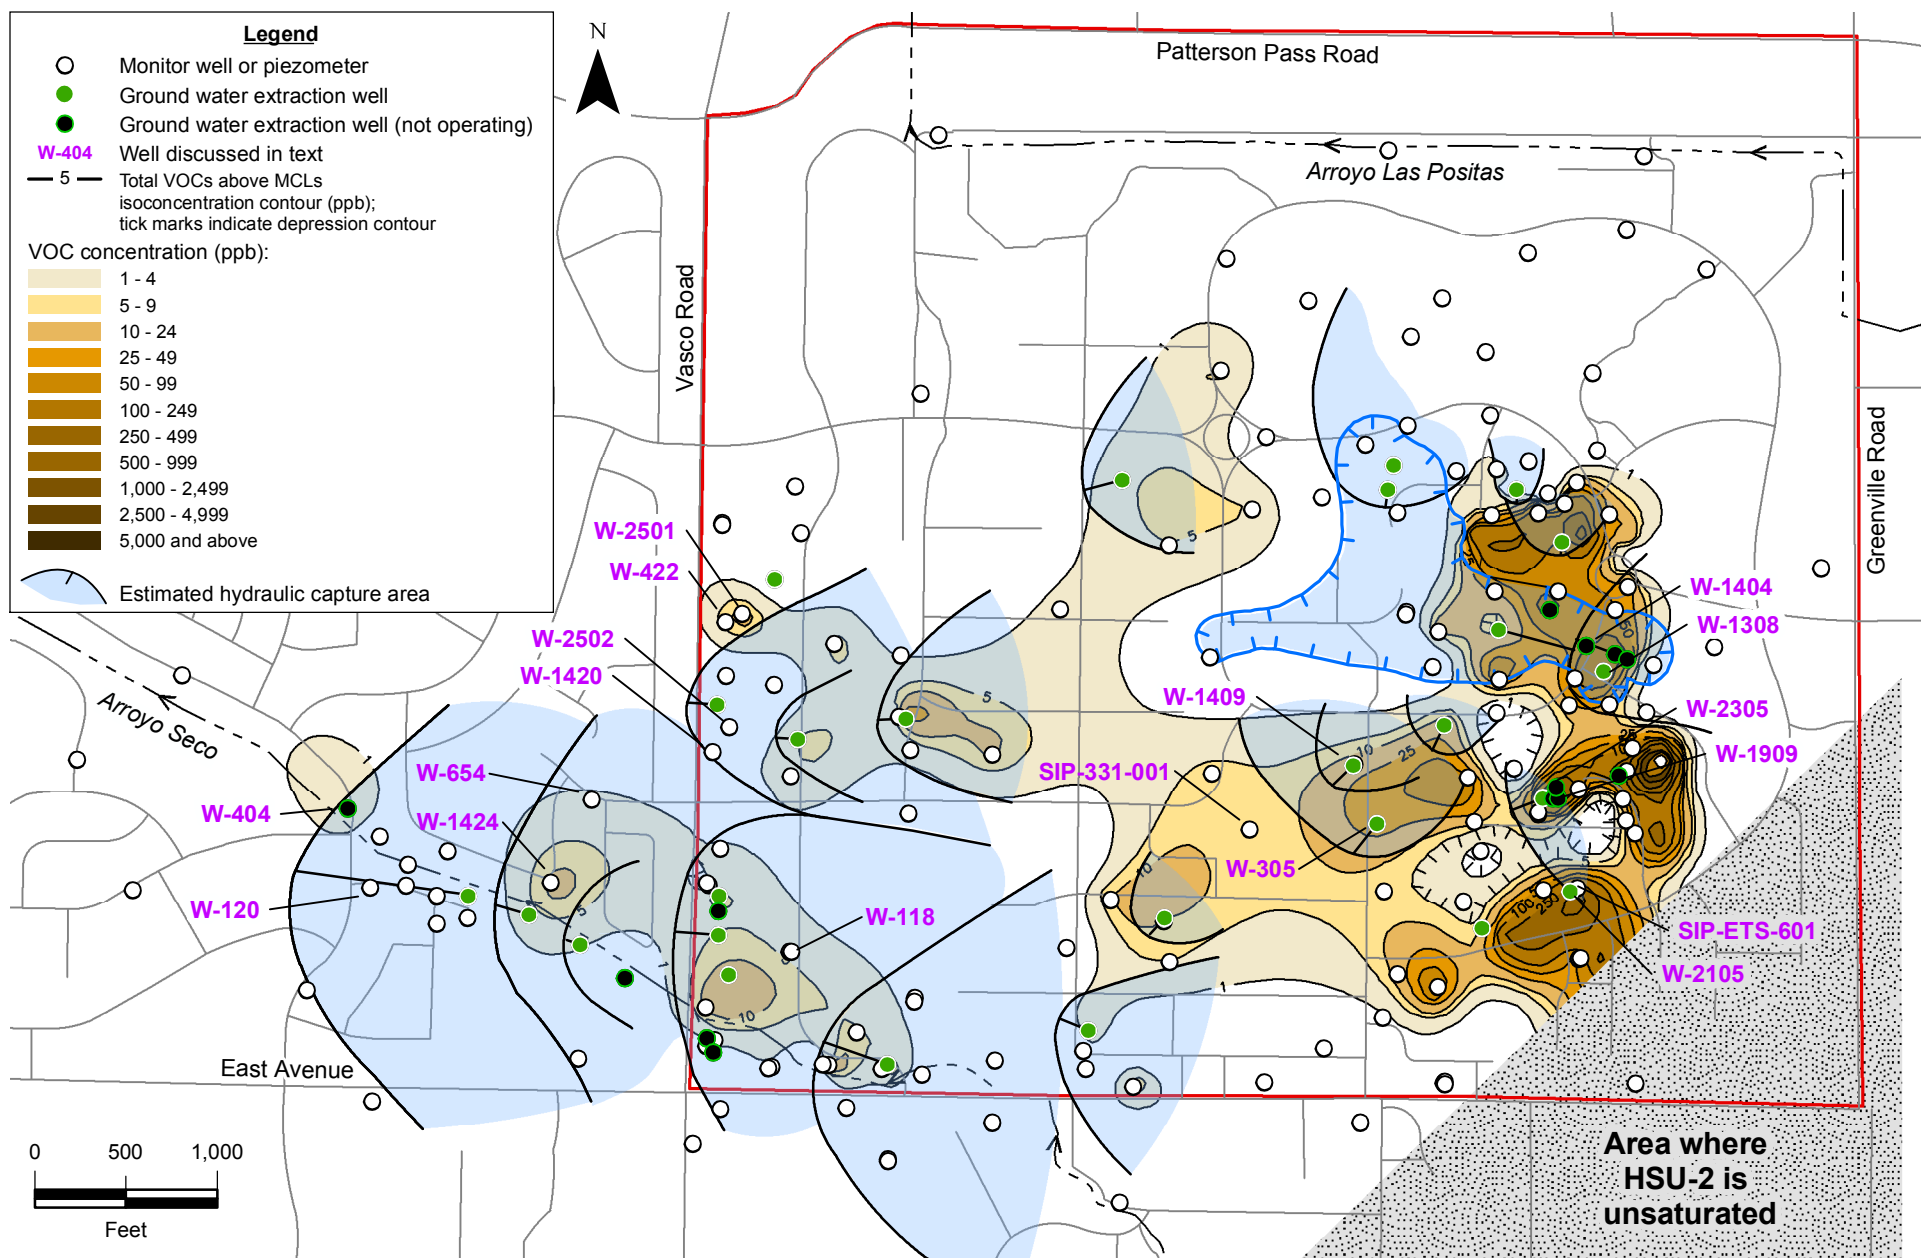
Figure 7. Isoconcentration contour map of total VOCs above MCLs from 197 wells completed within HSU 2, third quarter 2010 (or the next most recent data), and supplemented with soil chemistry data from 94 borehole locations.

VOC concentrations in HSU 2 declined slightly or remained unchanged in most areas along the western LLNL margin during 2010 (Figure 7). At TFA, a net decrease in VOC concentrations was noted in offsite wells, and no westward migration of the PCE plume was observed. PCE concentrations in monitor well W-654 declined from 12 ppb (April 2009) to 8 ppb (May 2010), while concentrations at nearby monitor well W-1424 increased from 11 ppb (April 2009) to 17 ppb (April 2010). PCE in non-operating TFA West extraction well W-404 remained unchanged at 10 ppb. At nearby monitor well W-120, PCE essentially remained unchanged April 2009 to July 2010. East of Vasco Road, PCE in monitor well W-118 decreased from 19 ppb (April 2009) to 5 ppb (April 2010). Throughout the TFA area, VOC concentrations are expected to continue their long-term decline in 2011 in response to continued ground water extraction and treatment operations.

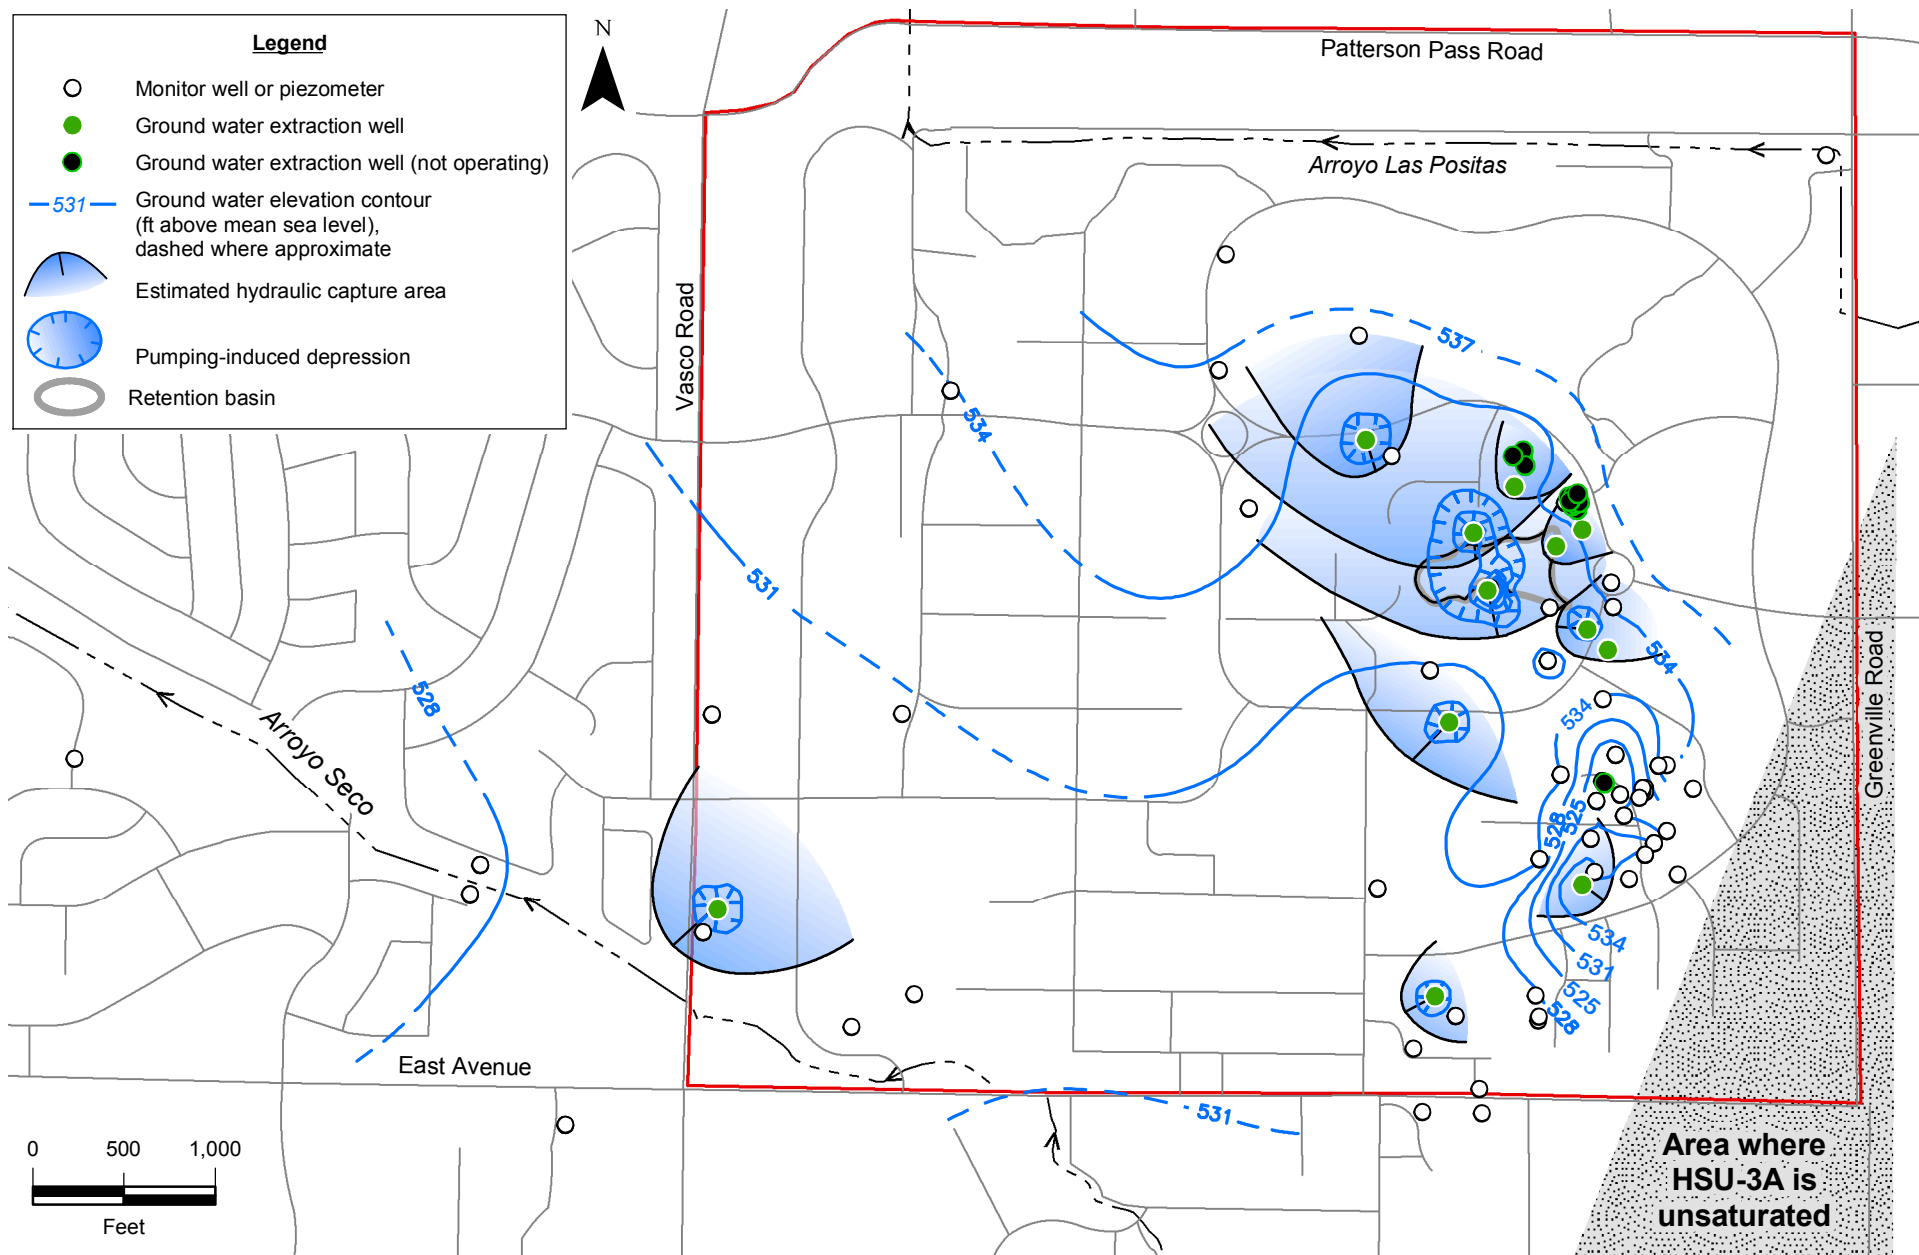
Figure 8. Ground water elevation contour map based on 112 wells completed within HSU 3A showing estimated hydraulic capture areas, LLNL and vicinity, July 2010.

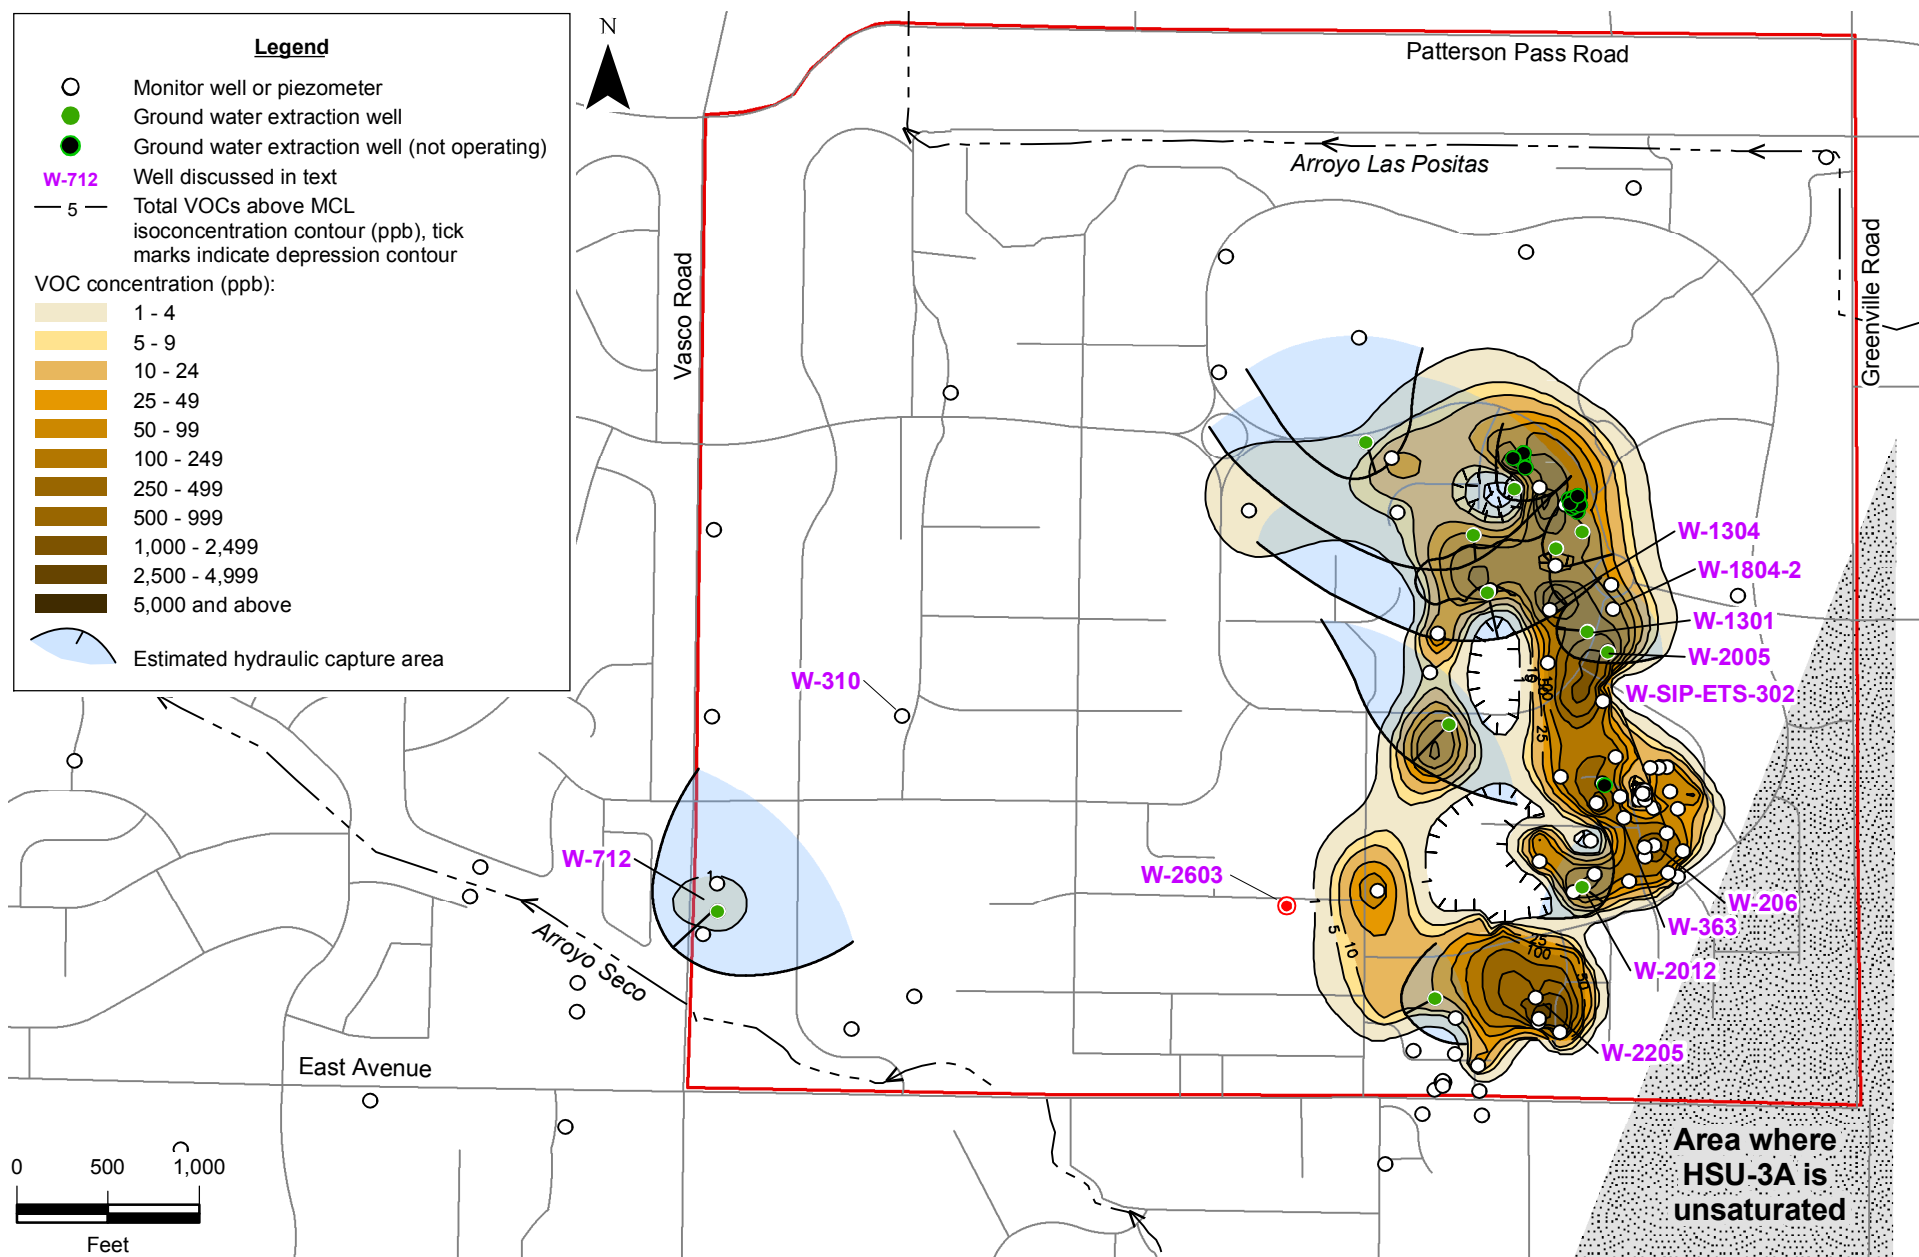
Figure 9. Isoconcentration contour map of total VOCs above MCLs from 112 wells completed within HSU 3A, third quarter 2010 (or the next most recent data), and supplemented with soil chemistry data from 144 borehole locations.

During 2010, very little change was observed in the size and location of the contaminant plumes in HSU 3A (Figure 9). However, some changes in VOC concentrations within these plumes were noted. In the TFD-SE area, a consistent decrease in VOC concentrations was observed. TCE declined in:

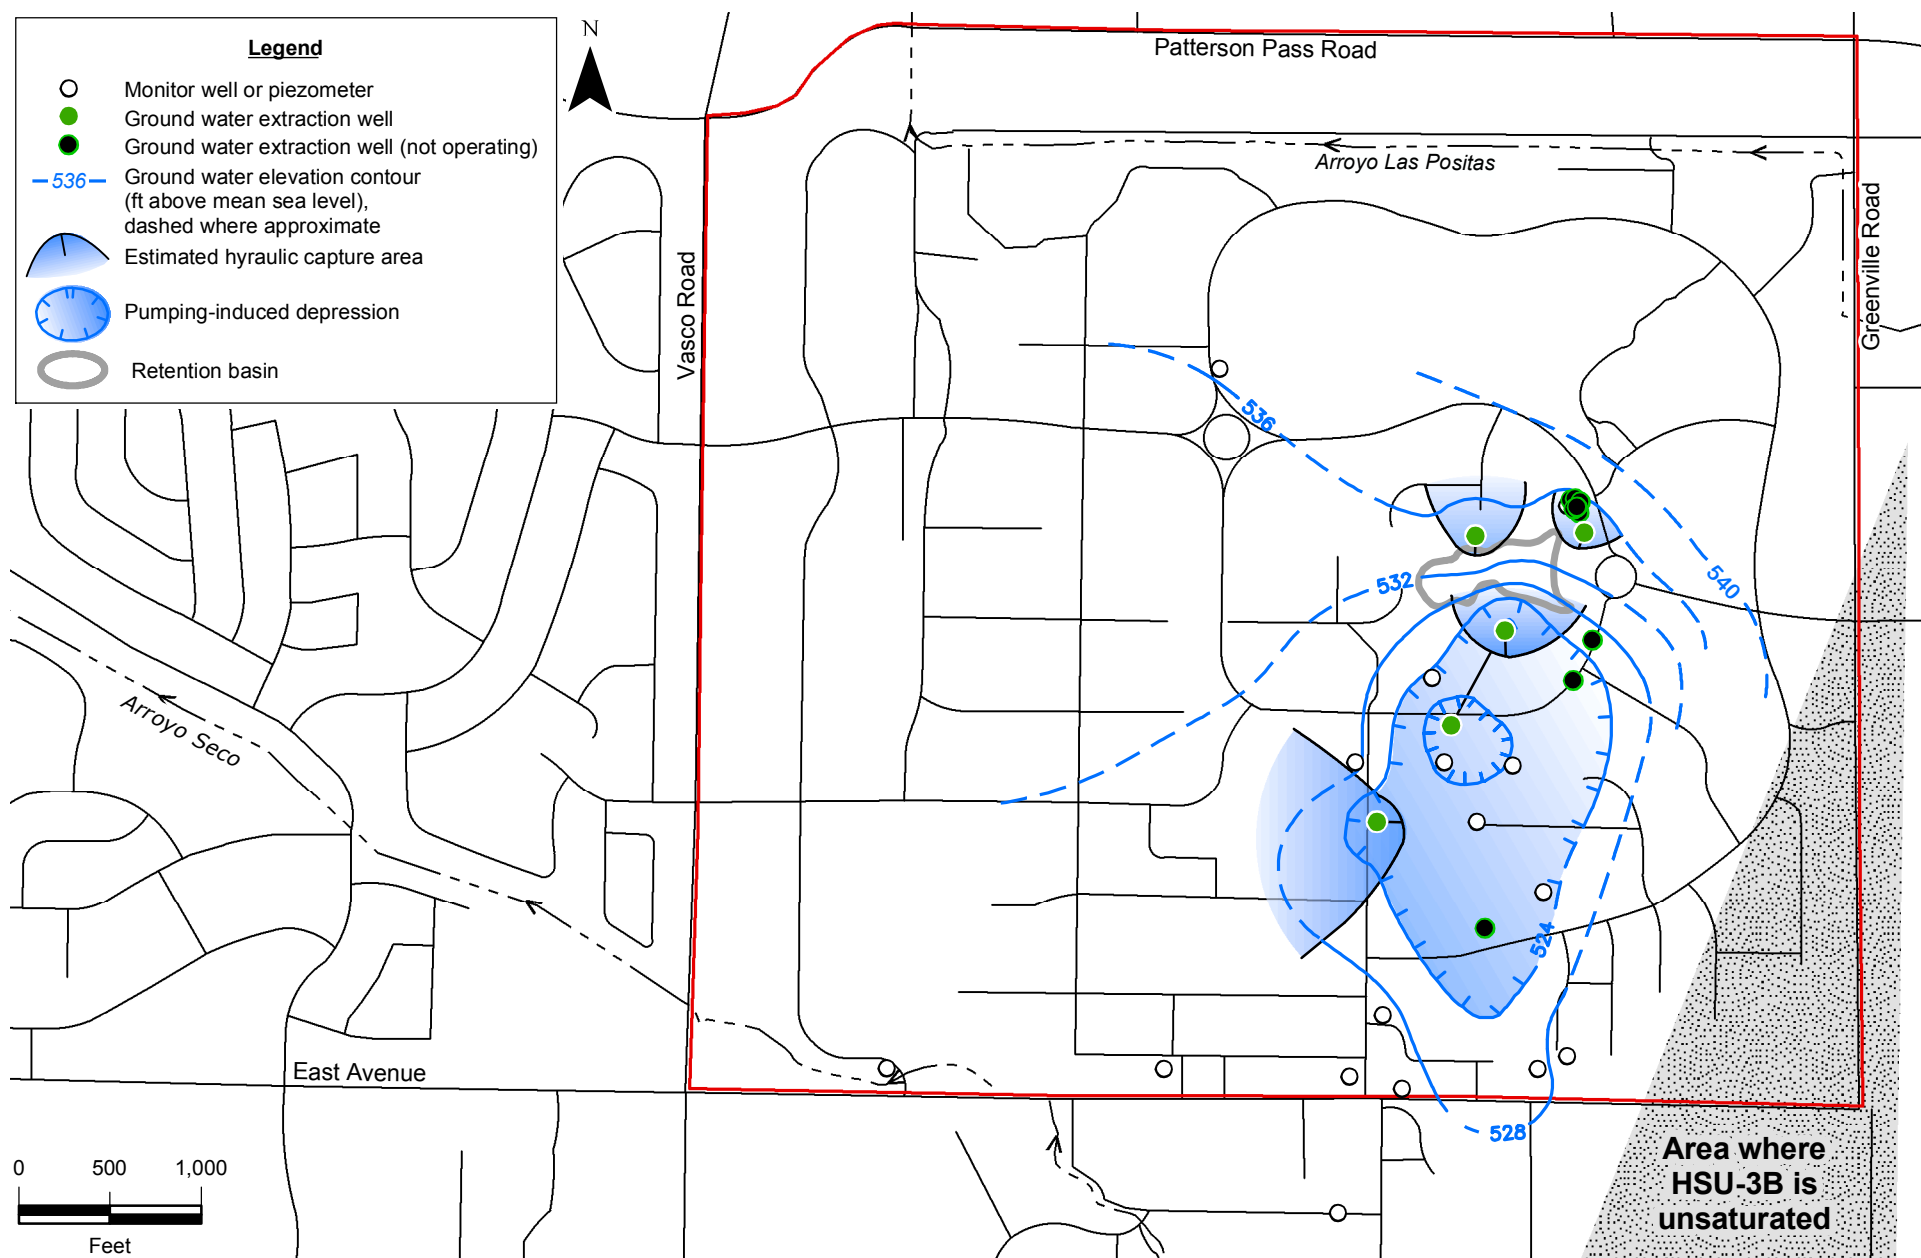
Figure 10. Ground water elevation contour map based on 40 wells completed within HSU 3B showing estimated hydraulic capture areas, LLNL and vicinity, July 2010.

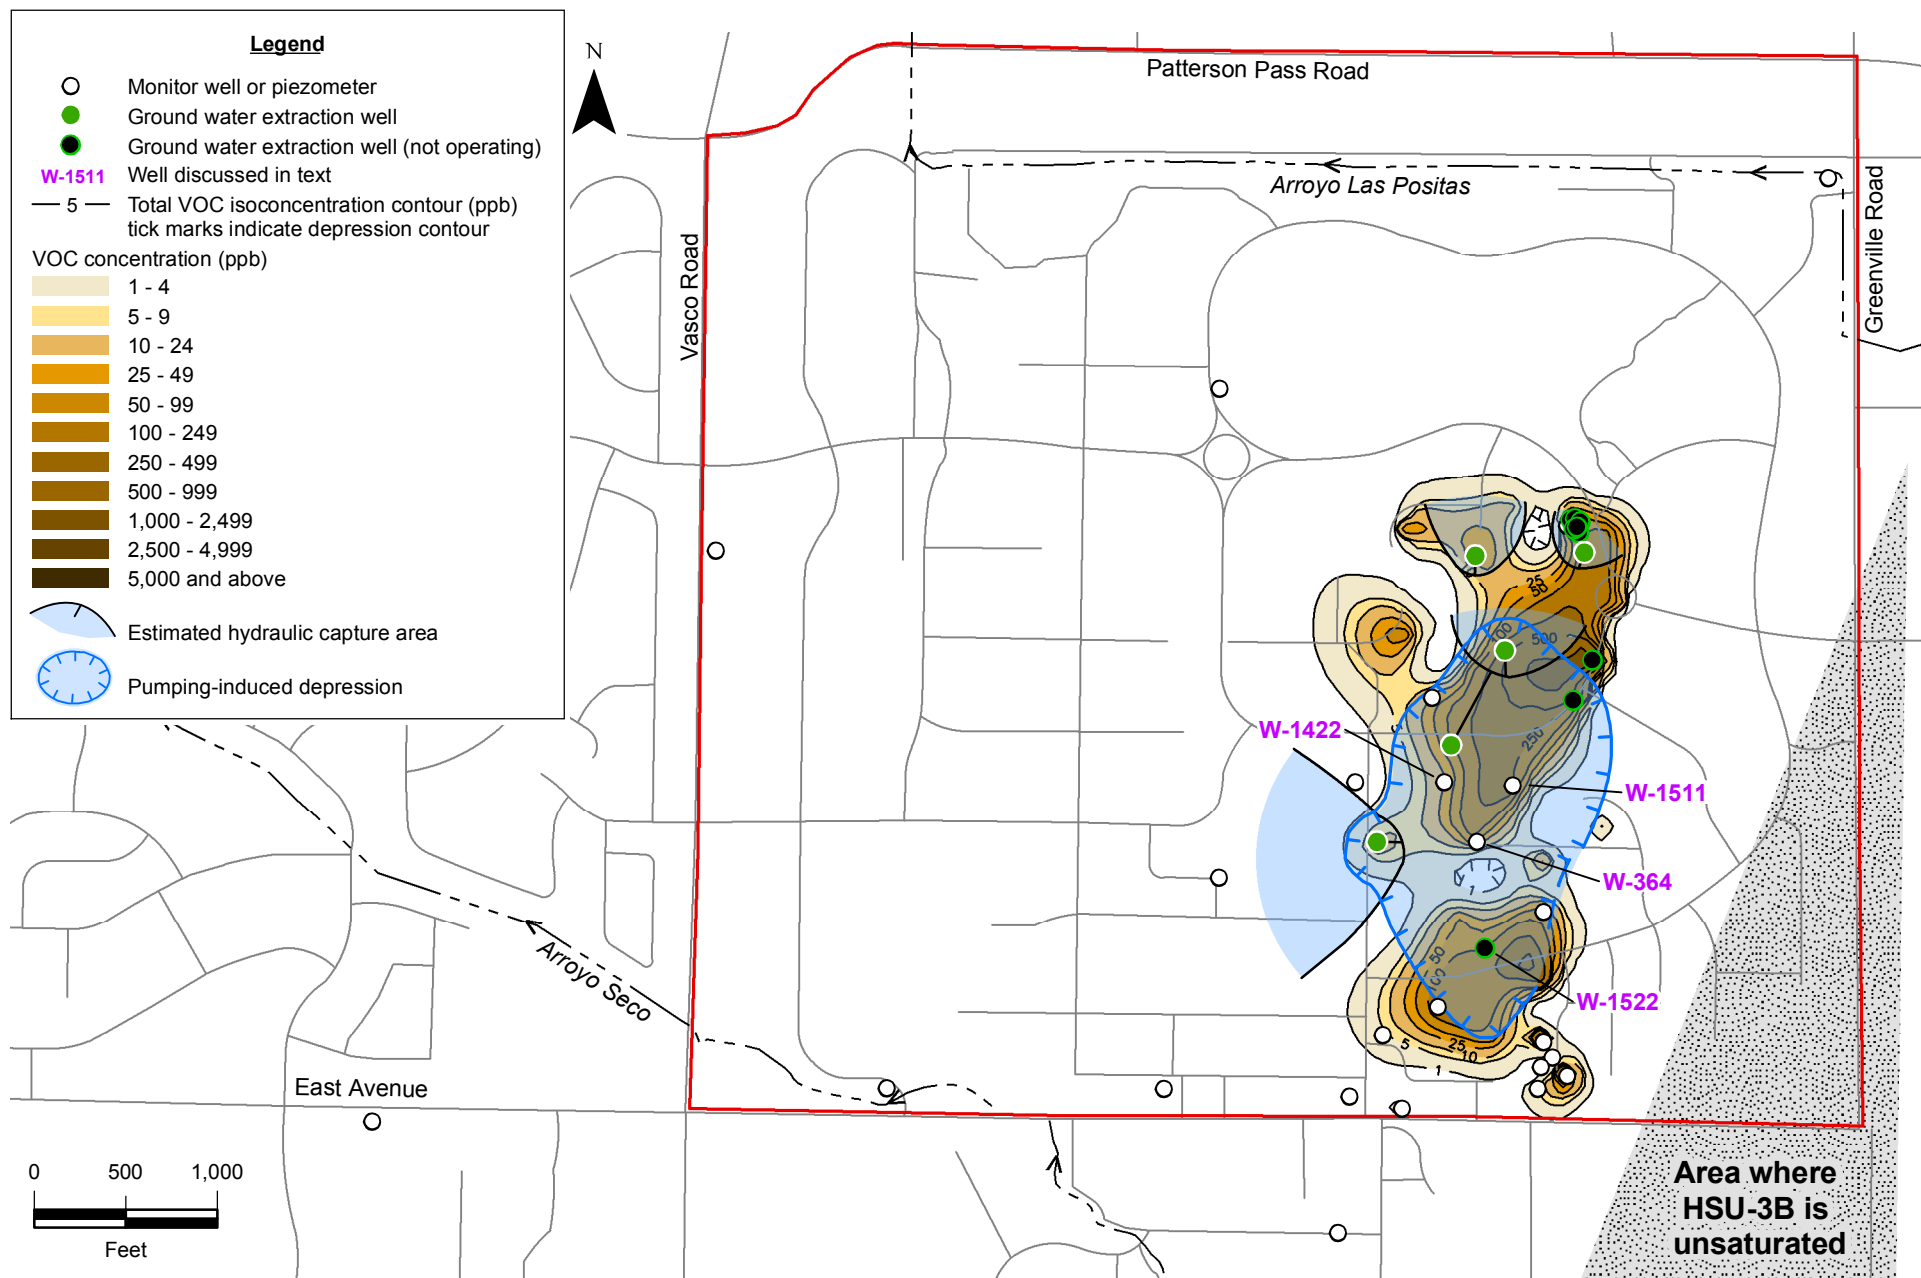
Figure 11. Isoconcentration contour map of total VOCs above MCLs from 40 wells completed within HSU 3B, third quarter 2010 (or the next most recent data), and supplemented with soil chemistry data from 109 borehole locations.

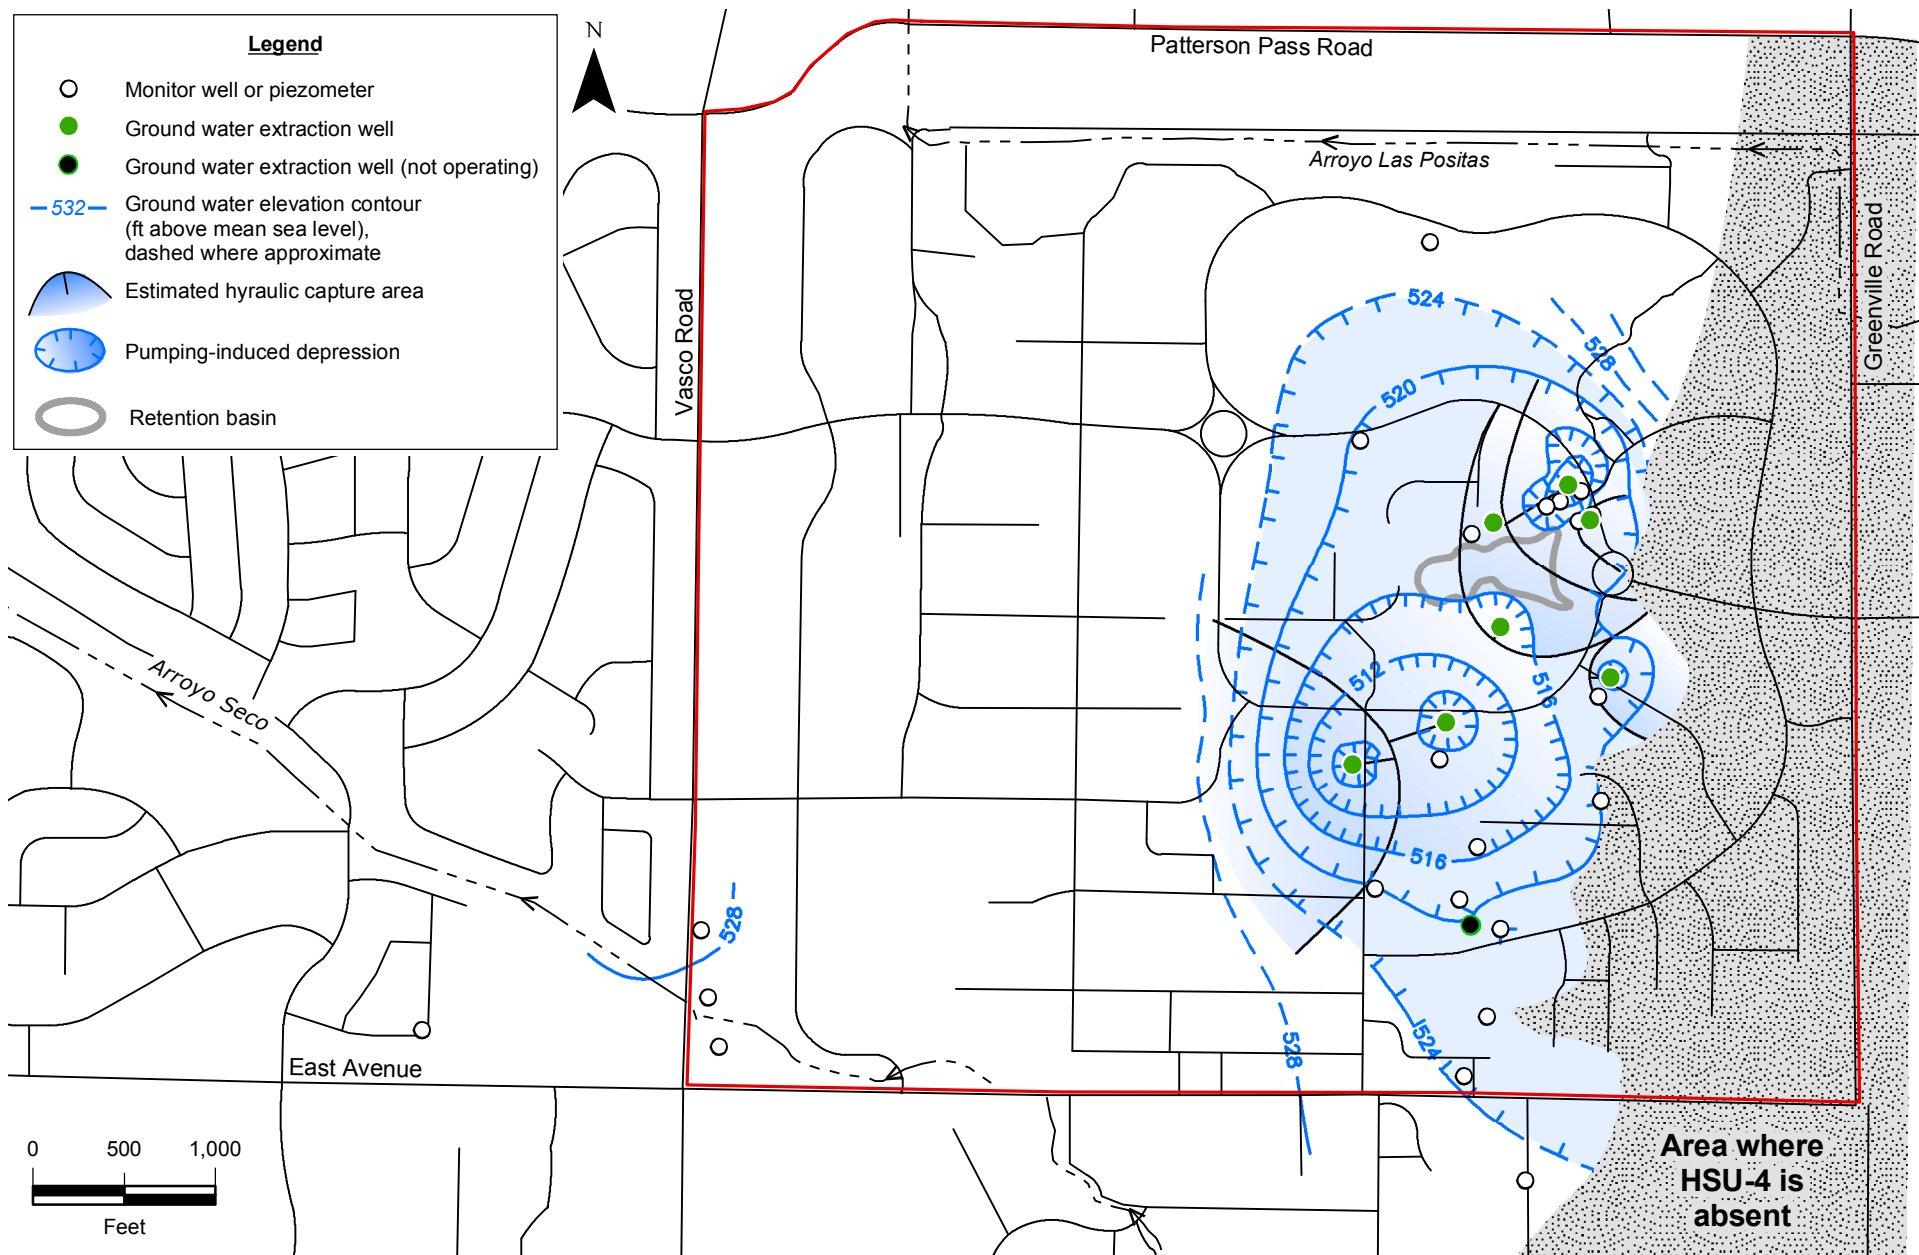
Figure 12. Ground water elevation contour map based on 42 wells completed within HSU 4 showing estimated hydraulic capture areas, LLNL and vicinity, July 2010.

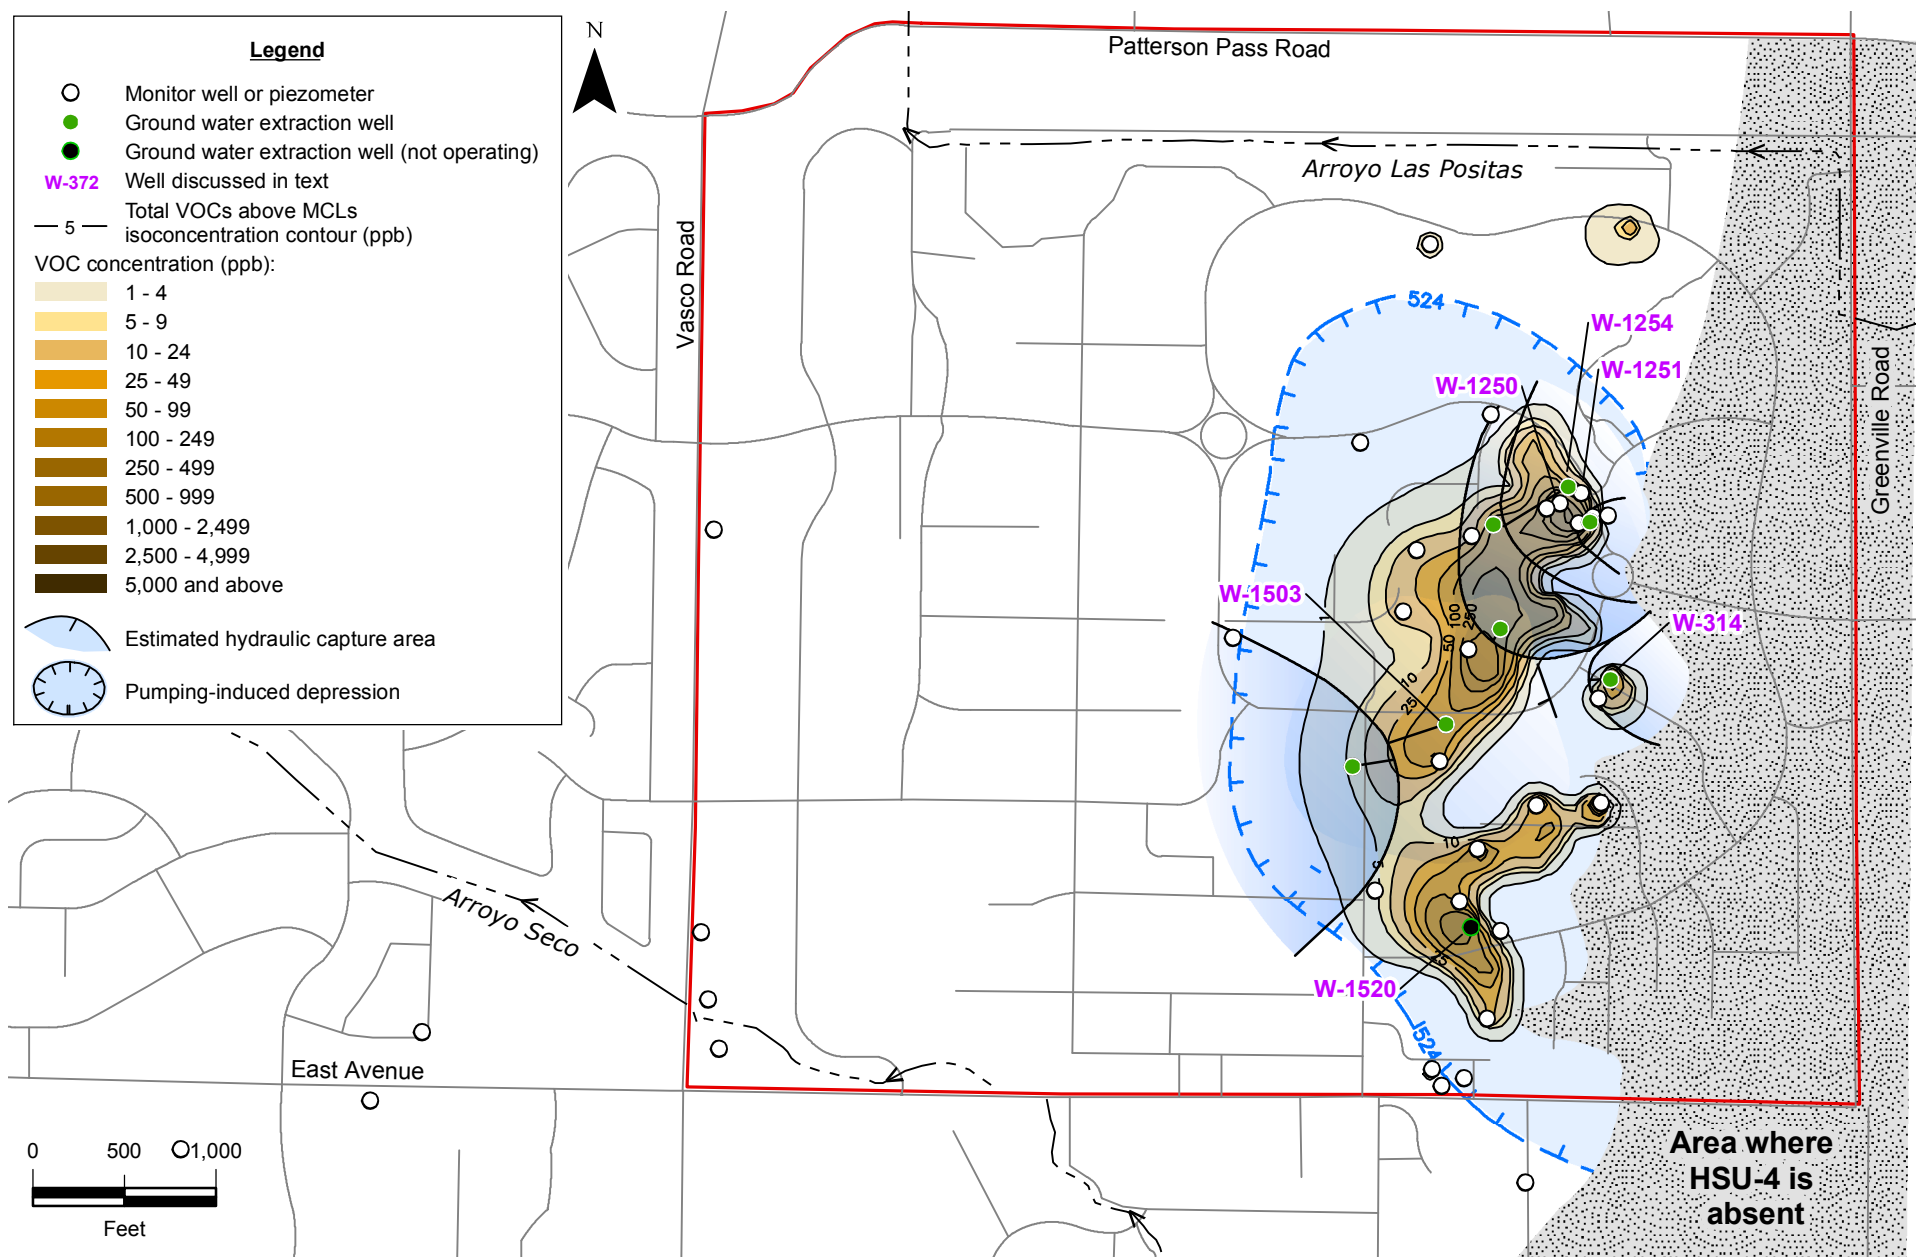
Figure 13. Isoconcentration contour map of total VOCs above MCLs from 42 wells completed within HSU 4, third quarter 2010 (or the next most recent data), and supplemented with soil chemistry data from 57 borehole locations.

Although the position and size of the HSU 4 VOC plumes (Figure 13) was essentially unchanged from 2009, several notable concentration trends were observed during 2010. In extraction well W-1503, located at TFD South, the source area VOC concentration rebound associated with the hiatus in pumping that occurred during 2008 and 2009 (Buscheck et. al., 2010) has now disappeared. TCE in ground water extraction well W-1503, which operated throughout the year, declined from 200 ppb (July 2009) to 75 ppb (July 2010). The latter is similar to concentrations observed prior to the shutdown (e.g., 80 ppb in April 2008).

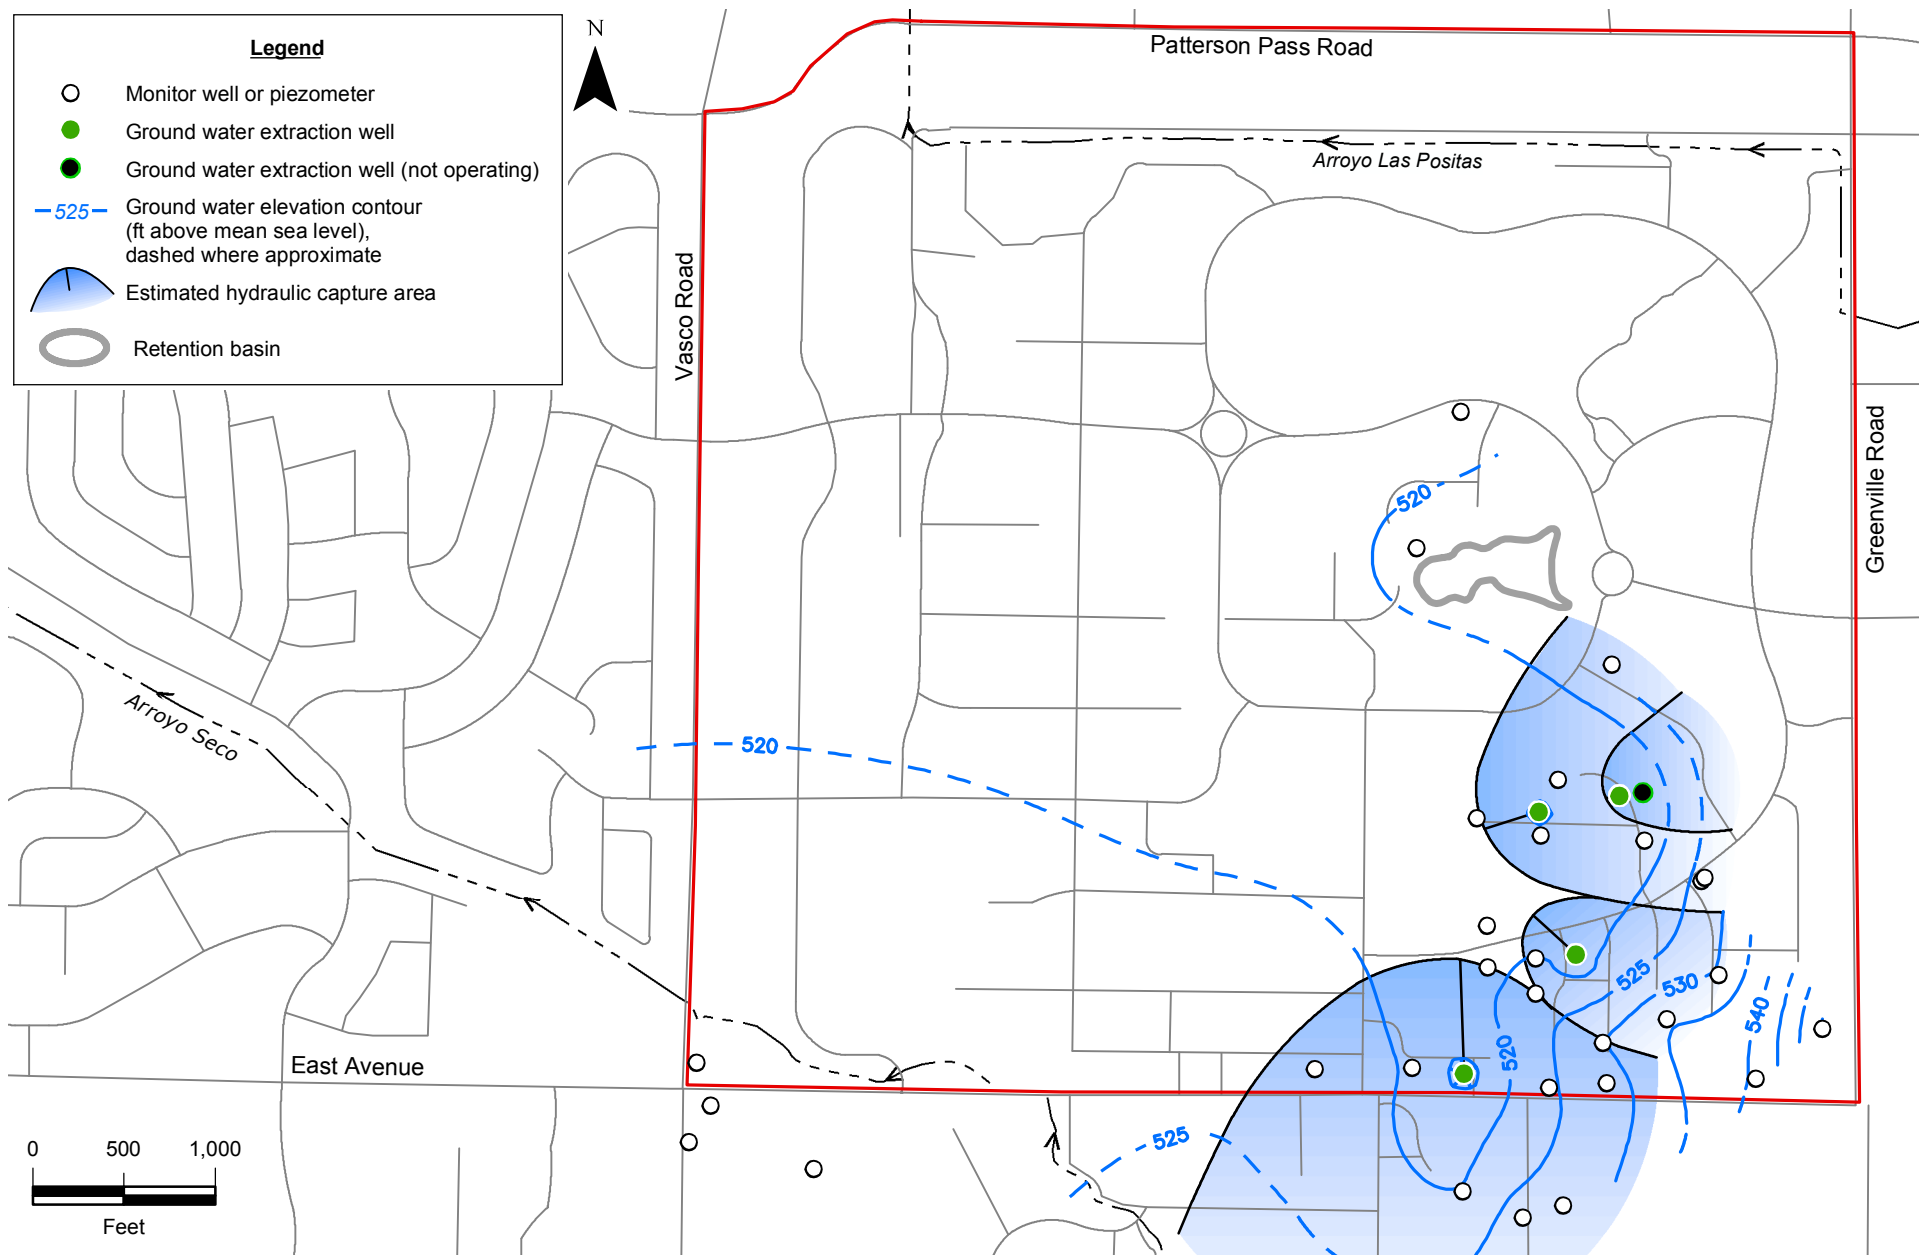
Figure 14. Ground water elevation contour map based on 60 wells completed within HSU 5 showing estimated hydraulic capture areas, LLNL and vicinity, July 2010.
